**NOTICE OF VIOLATION, CONSTRUCTION STORM WATER GENERAL PERMIT NO. CAS000002, EAST BAY MUNICIPAL UTILITY DISTRICT, WDID NO. 5S39C351737, SAN JOAQUIN COUNTY**

# Storm Water Construction General Permit Inspection Report

Insp. Date & Time:	2/17/09	Inspected By:	R Muhl
WDID #	5S39C351737	Site County:	San Joaquin
Owner Name:	East Bay Mud Municipal District		
Site Name:	SJ Louis Construction Inc		
Site Address:	Folsom S Canal Connection Project

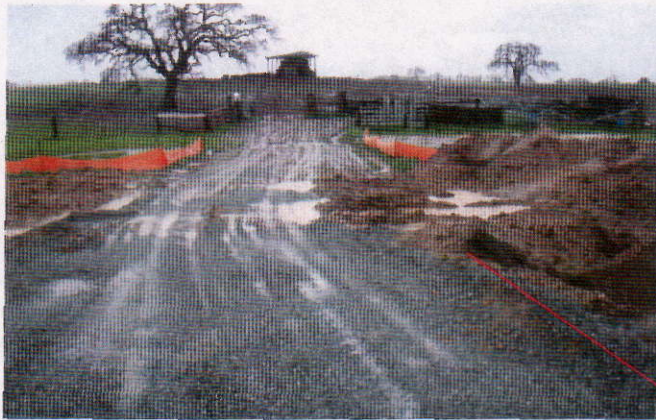
**Figure 1** Unstabilized stockpiles directly adjacent to the rock roadway.

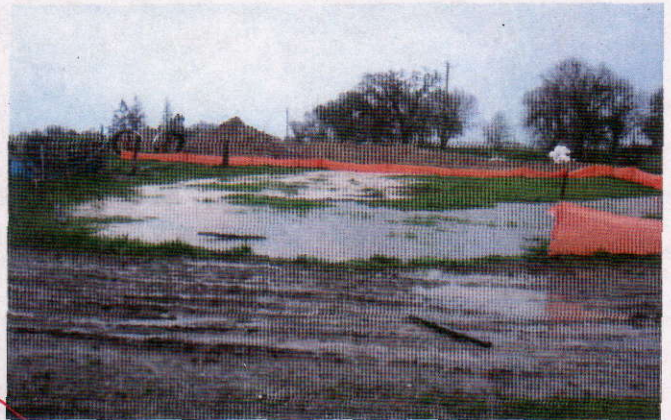
**Figure 2:** Location where storm water discharges under the roadway. Red line shows approximate location of culvert.

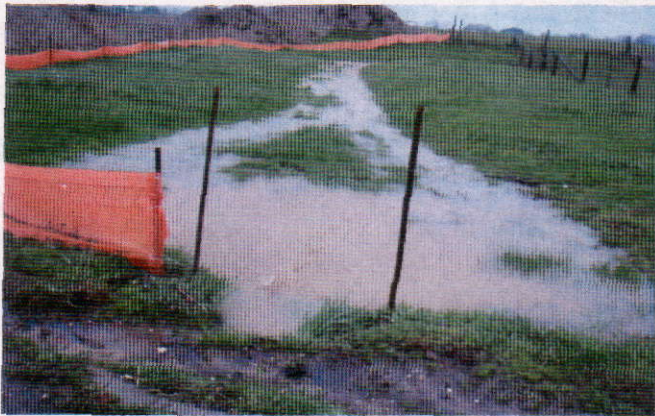
**Figure 3:** Another view of the turbid flow from the project.

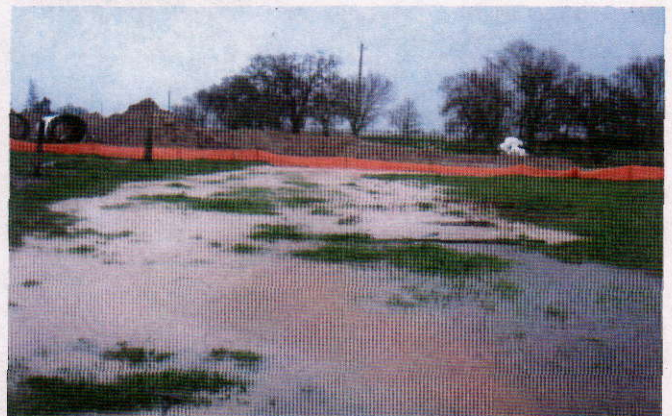
The discharge of sediment-laden water from your site is a violation of Discharge Prohibition A.3 of the General Permit, which states, *"Storm water discharges shall not cause or threaten to cause pollution, contamination, or nuisance."* Sediment-laden storm water from your construction site threatened to cause a condition of pollution and/or nuisance in surface waters, therefore, is a violation of Prohibition A. 3 (see photographs 4, 10 and 11).

**Figure 4:** Area where turbid flow from the project mixed with clean flow from the creek.

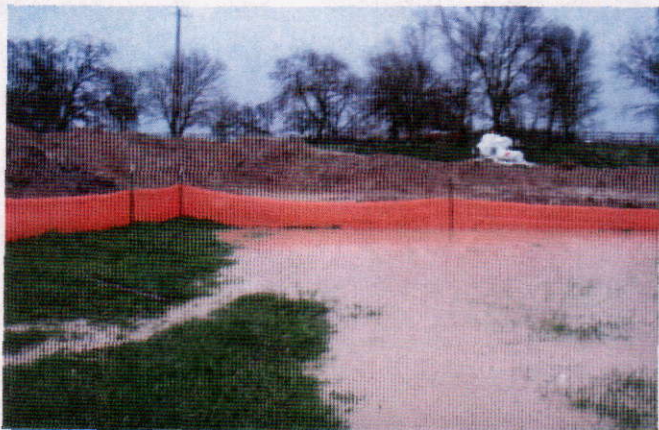
**Figure 5:** Another view of the turbidity. Note the unstabilized stockpile of dirt. The contractor stated that the BMPs sprayed on the stockpile failed.

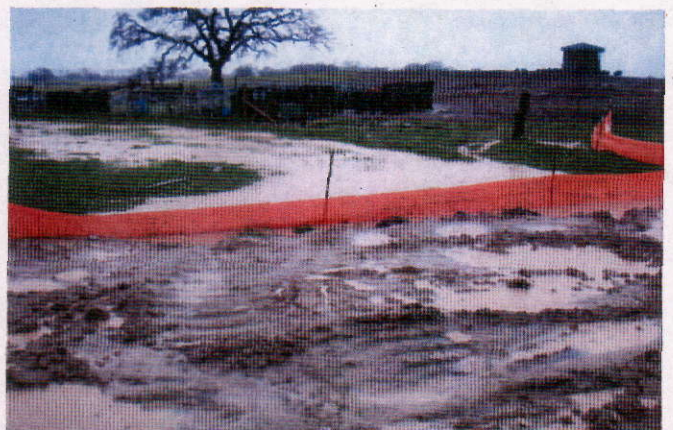
**Figure 6:** Unstabilized area directly adjacent to the silt fence. Storm water appeared to have backed up into the work area.

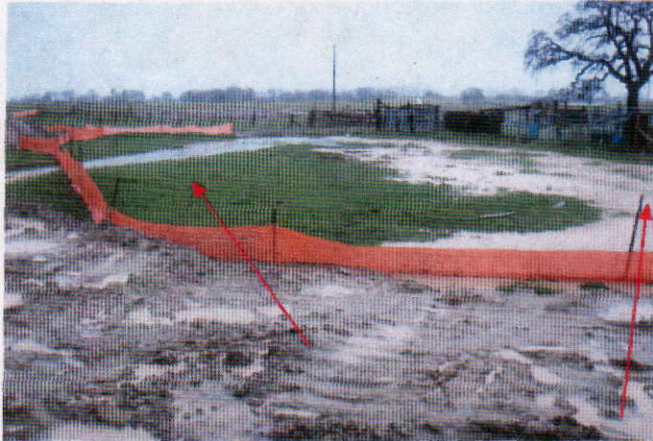
**Figure 7:** Another view of the problem area. Note the clean water in the creek and the turbid storm water from the construction site.

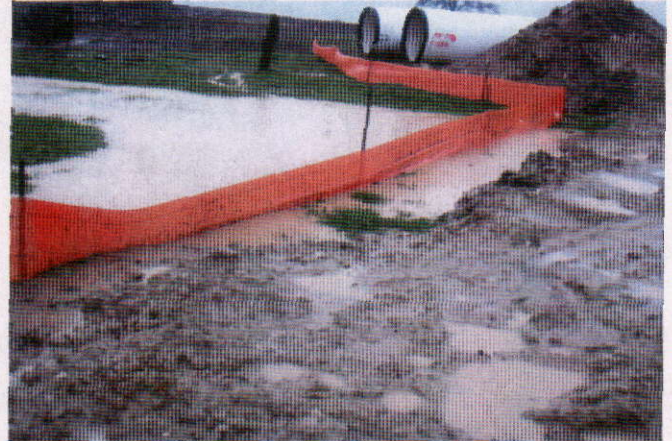
**Figure 8:** Another view of poorly stabilized area.

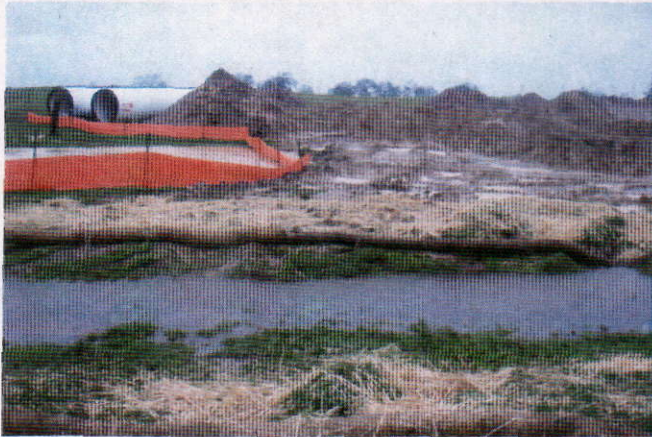
**Figure 9:** Another view of the poorly stabilized construction site. Note the clear storm water in the creek channel.

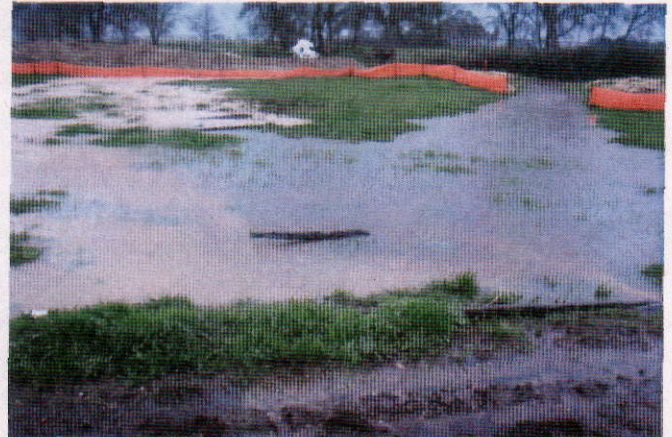
**Figure 10:** Turbid storm water from the site mixing with clear water from the creek

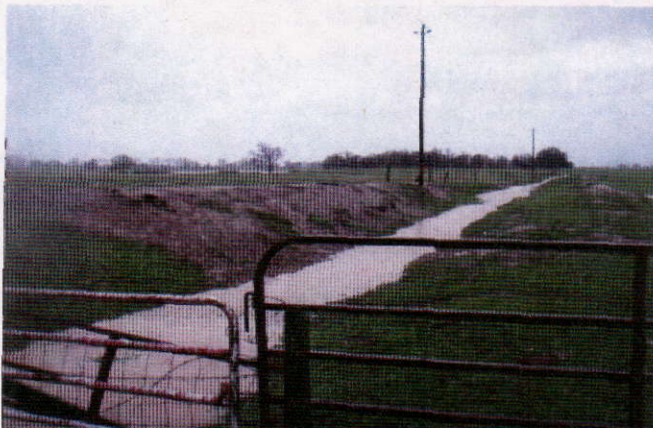
**Figure 11:** Turbid storm water in the channel. Photograph is taken at the boundary of the project looking east
